Can overcrowding a BSC work area lead to **a loss of containment?**

WITH
KARA HELD Ph.D.
BAKER SCIENCE DIRECTOR

ABSTRACT

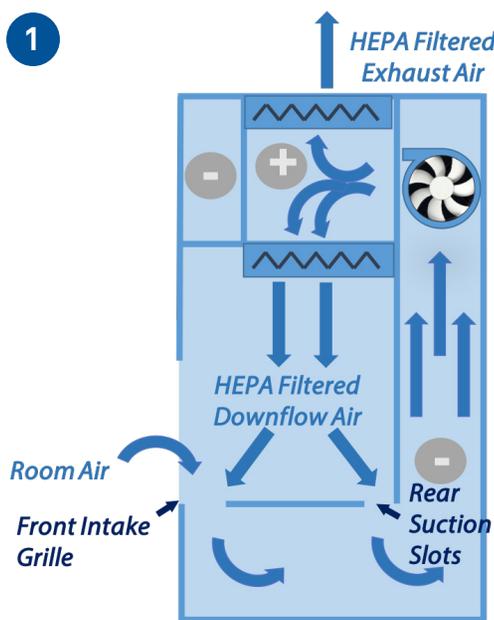
Figure 1
Class II Type A2 Biosafety Cabinet schematic depicting airflow patterns and design features.

Biosafety cabinets (BSCs) are a common tool used in many laboratories to provide contamination control for the experiments and a safe working conditions for the workers. These BSCs depend on directional airflow and HEPA filters to remove contaminants from the environment and prevent their spread, requiring proper usage of the BSC. It is common to see BSC users blocking the front intake grille or rear suction slots (**Figure 1**) with various

The impacts on airflow dynamics within the BSC with front intake grille blockage and overcrowded work areas are little known to researchers and laboratory personnel as both directly correlate to the BSC's ability to provide safe and clean working conditions for both personnel and products involved (**Figure 1**). It is important to understand how airflow functions in a hood and what could be potential factors in affecting its proper flow and function. Under non-cluttered working conditions without the front intake grille covered, the air travels into the front intake grille to prevent any contaminants from escaping. The air will then travel up through the back and side plenums to the motor/blower.

Here the air splits, and a portion of the air will be pushed through the supply HEPA filter and unidirectional downflow air will flow down to the work surface where it provides product protection to the work being done. The air will then split, and some will return through the back return slots, and some will flow into the front grille.

The remainder of the air will be exhausted through the exhaust HEPA filter to provide environmental protection to the surrounding areas. According to NSF International Standard 49, the criteria for build and functioning operations of BSCs, the cabinet should maintain a minimum standard of air cleanliness (NSF, 2018).

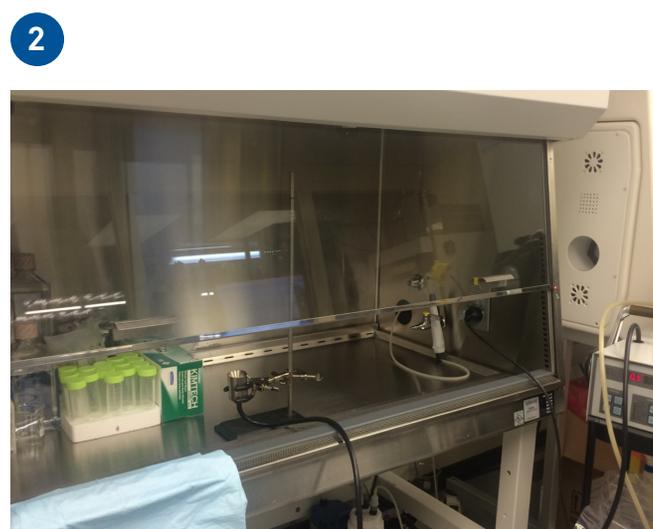
Figure 2
Experimental set up showing 25% of the work surface covered, 25% of the front intake grille blocked, and the particle counter and probe set in place within the BSC.

materials such as absorbent pads (“diapers”) or lab notebooks while working within the BSC as well as filling the work area with various supplies and using the cabinet for storage instead of just work (**Figure 2**). In the BSC manuals, it states that these cabinets should be operated with the vents free from obstruction and not used to store any materials, but that is not always translated into practice.

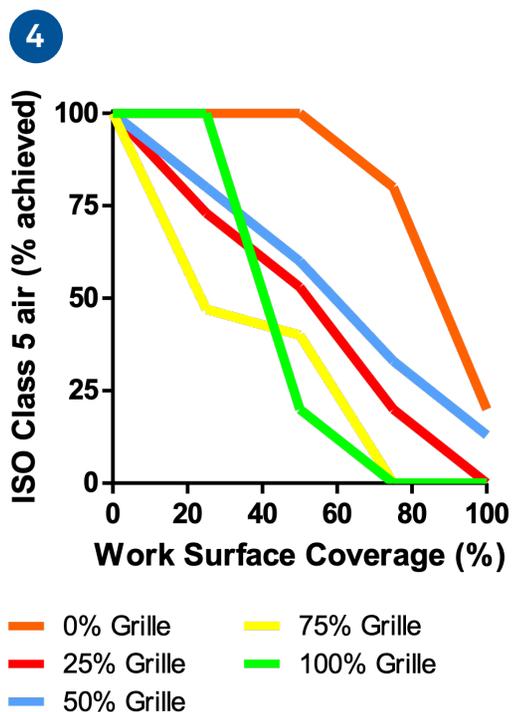
Figure 4

Correlation between Work Surface and Front Intake Grille coverage and the ability of the BSC to maintain ISO Class 5 air.

Covering the work area obstructs airflow throughout the BSC, leading to breaches of containment and potential contaminations. As seen in Figure 4, there is a direct inverse correlation between work area coverage and the ability of the BSC to maintain ISO Class 5 air. Interestingly, when increased portions of the front intake grille were covered, the ability of the BSC to maintain ISO Class 5 air was decreased (Figures 4 and 5, $r^2 = 0.9967$). In Figure 4, a leftward shift of the lines indicate that ISO Class 5 air was not achieved with less coverage of the work area if the front grille was covered.

Covering of the front intake grille of the BSC was directly correlated to the BSC failing to reach ISO air cleanliness standards (Figure 4). When 100% of the front grille was covered, nearly all the tests also failed. The amount of coverage of the work area negatively trended with ability to meet ISO Class 5 air within the BSC. The least amount of success to reach ISO Class 5 air was seen when 75% and 100% of the surface area was covered (Figure 4), however, if the front access opening grille was completely uncovered, the cabinet was sometimes able to maintain ISO Class 5 air. However, this was not consistent, and may still pose a significant risk to the worker or work being conducted within the cabinet.

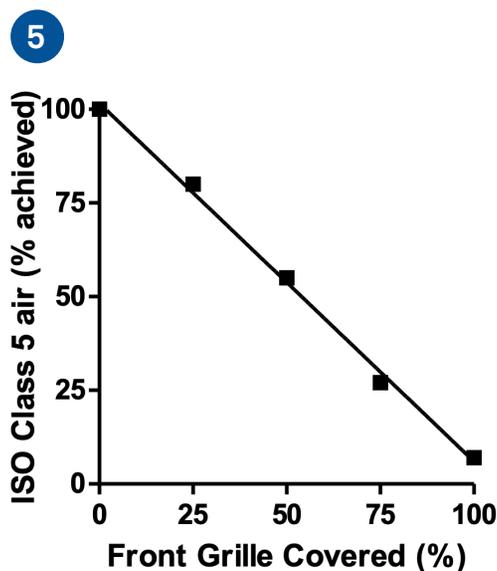
Figure 5

The correlation between coverage of the front intake grille and ability of the BSC to maintain ISO Class 5 air is shown. $r^2 = 0.9967$

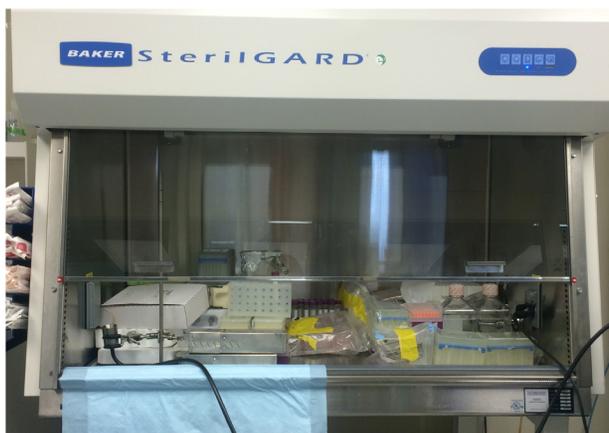
Figure 7

An exaggerated work set up with the entire work area of the BSC covered excepting a small 6-inch region in the center and 50% of the front intake grille covered, with the particle counter probe in place.

We finalized our testing procedures with setting up a scenario that might mimic an exaggerated overcrowded BSC. We filled the work area with lab items and materials, covering the entire surface area for the hood except for a 6-inch zone at the front center of the cabinet (**Figure 7**). These tests yielded consistent failure to reach ISO Class 5 air cleanliness standards, except for when the front grille was not covered at all (**Figure 8**).

The exaggerated scenario tested where the entire cabinet was filled except for a small 6-inch area showed how problems can quickly escalate (**Figure 7 and 8**). This may seem extreme, but this situation has been witnessed in laboratories across the world.

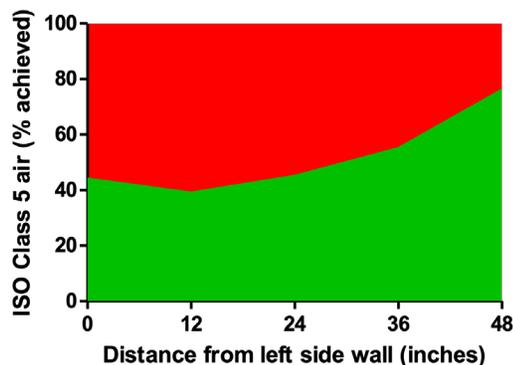
Figure 6

Locations within the BSC along the front access opening vary slightly in the ability to maintain ISO Class 5 air.

Certain regions of the BSC were determined to have the highest level of particle escape leading to failure to meet ISO Class 5 specifications, specifically the left half of the cabinet just inside the front access opening (0-36", **Figure 6**). Once the front grille was covered in these "hotspot" locations, it was common to see increases in the particle counter readings, meaning more particles or potential contaminants were able to enter the BSC.

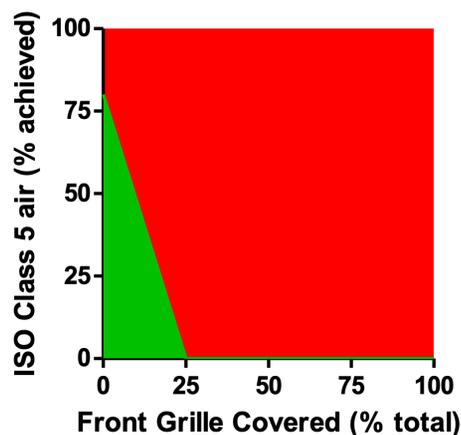
Figure 8

Percentage of Failed tests as the front grille is covered when the work surface is completely full excepting a 6 inch work area.
